# FURE'S CABIN

## HISTORIC STRUCTURE REPORT

KATMAI NATIONAL PARK & PRESERVE

BAY OF ISLANDS, NAKNEK LAKE

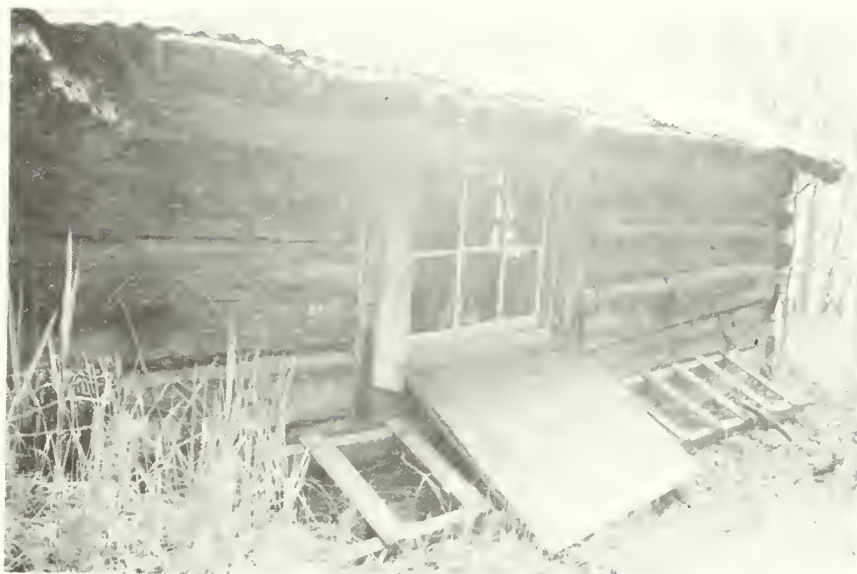
Photograph 3  
West Elevation: Note Deteriorated Condition of  
Roof Planks  
6/82 D. Snow

- 9) Once corrugated roofing is removed, inspect roof planks for extent of deterioration.
- Roof Repair      10) Replace with new ones any roof planks that have lost structural integrity (loss of more than 30% of thickness). Hand hew new planks on the exposed underside. Retain roof planks judged in acceptable condition and remove dry rot with hand tools.

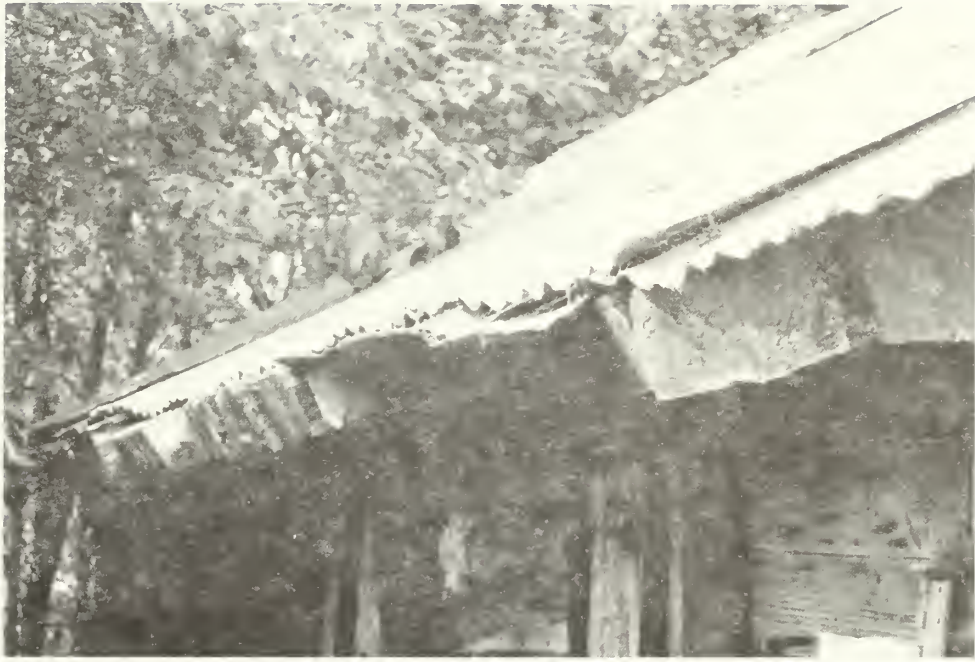
The roof planks are sheathed with corrugated metal at the exterior. There are signs of rot at the butts of many of the planks because the corrugated metal does not uniformly cover the last inch of the plank. Water running off the roof is being soaked up into the end-grain and causing damage. It should be noted that the end-grain of the roof planks and the corrugated metal have all been treated historically with what appears to be red paint, similar to that found on wall corners.

Photograph 11  
Roof Planks Ends at East  
Elevation  
6/28/83 D.C. Anderson

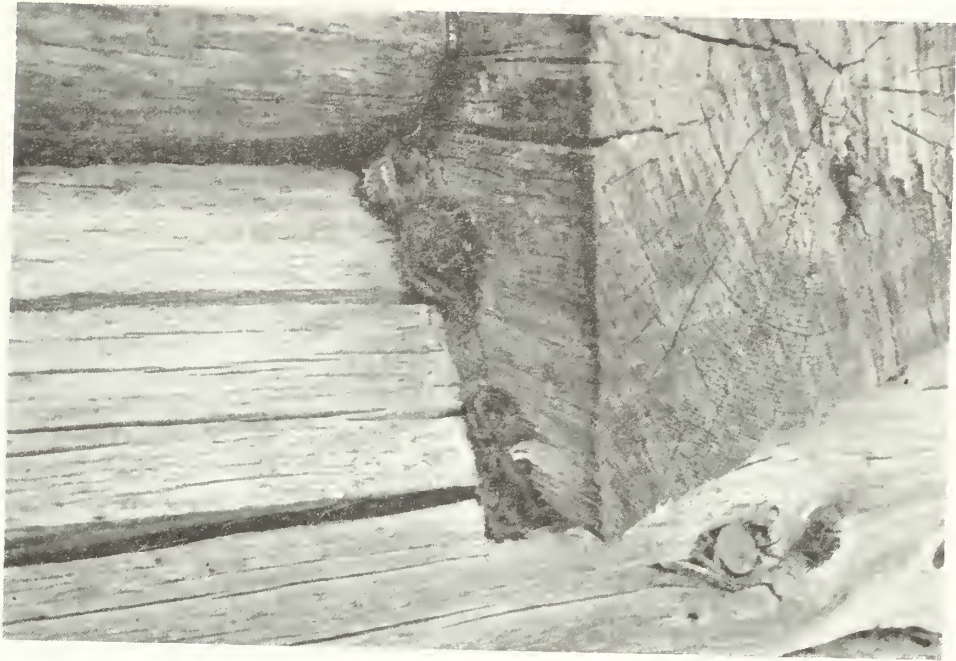
The corner joints are all dovetailed with a high degree of craftsmanship and still fit tight. At various points there is evidence of large spikes having been driven into the dovetailed joints. All end-grain of these joints is painted with red paint. The paint appears to have been a regular maintenance operation in the upkeep of this structure performed by the owner, Roy Fure. The paint has remained in fair condition, thus slowing deterioration at the log butts.

Photograph 43  
Typical Dovetail Joint: Note  
Paint on End Grain  
6/82 D. Snow

- 13) Paint all dovetail end grain with red oil base paint after priming with mixture of 50% boiled linseed oil and 50% turpentine.
- Window Repair      14) Repair all existing windows by replacing broken glass and repairing or restoring sash. Paint red restored sashes and glazing compound. (Several weeks may be required for glazing compound to set up.)

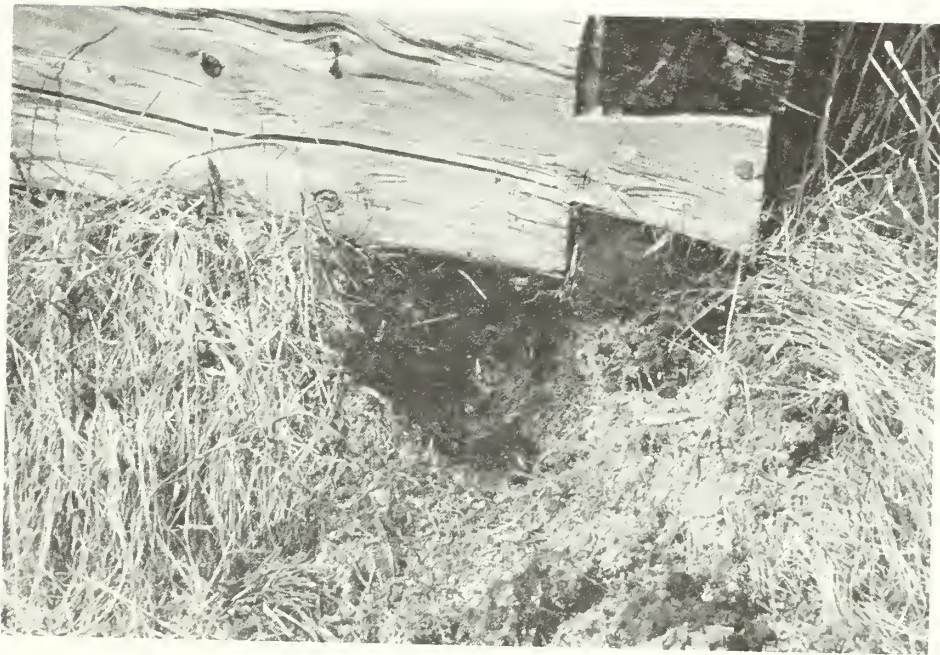
The existing condition of the sill logs is obvious because they have been in constant contact with the soil since the cabin was constructed. There is uniform dry rot primarily below the grade. This problem is compounded at the north elevation and the north end of the west elevation because the structure is built into the hillside. At least three courses of these wall logs, above the floor level, are in direct contact with soil at their exterior face.

Photograph 44  
Northeast Corner: Note  
Rotted Sill Log  
6/82 D. Snow

| | 2) Remove sill logs that have lost their structural integrity and replace with pressure-treated timbers (Douglas Fir) as indicated in Stabilization Drawings. |

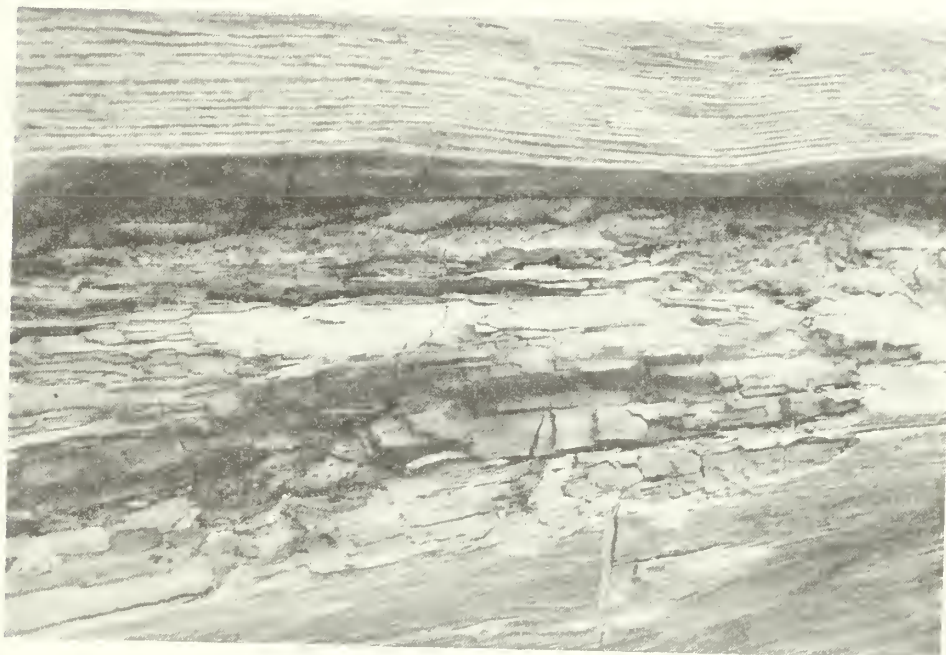
Photograph 48  
North Elevation of Cabin Above Window:  
Note isolated Dry Rot  
6/82 D. Snow
